Preliminary Results of Post-Disaster Archaeological Investigations at the Kasthamandap and within Hanuman Dhoka, Kathmandu Valley UNESCO World Heritage Property (Nepal)

Coningham, R.A.E.¹, Acharya, K.P.², Davis, C.E.¹, Kunwar, R.B.³, Simpson, I.A.⁴, Schmidt, A.¹ and Tremblay, J.C.¹,

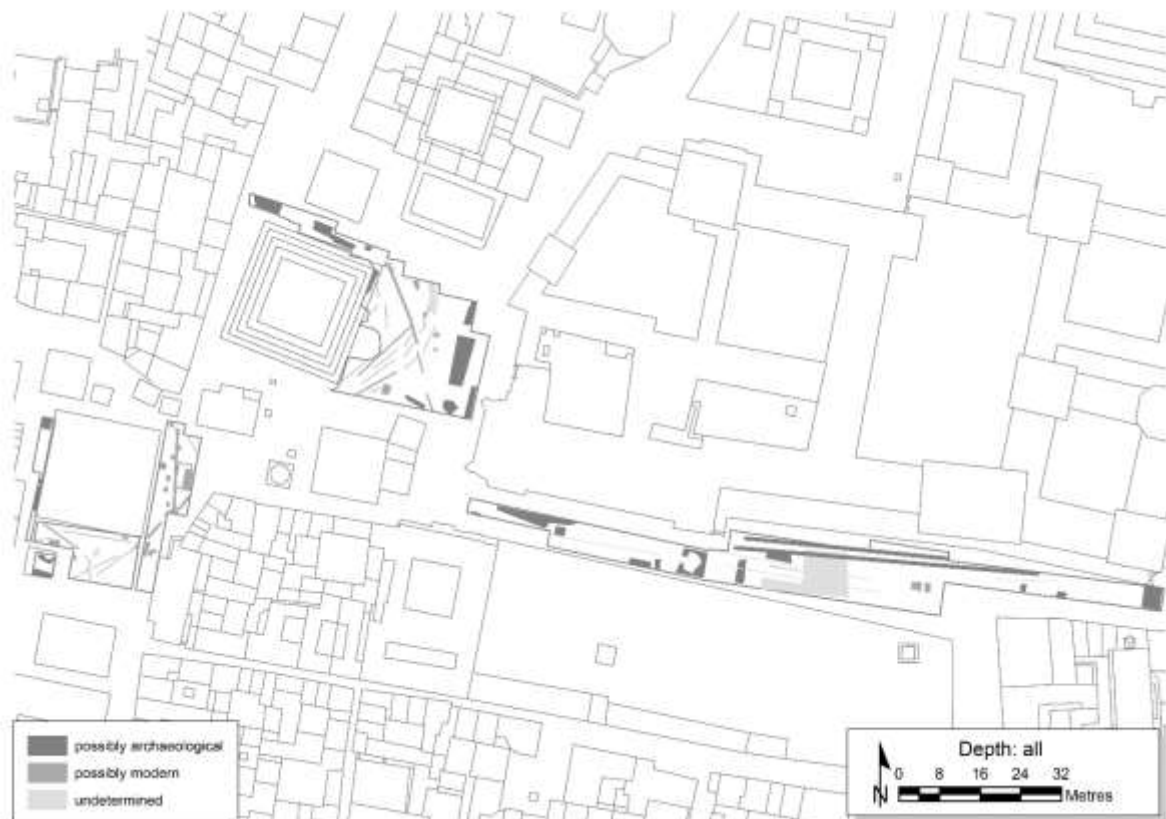
Figure 22: Archaeological interpretation of GPR results across Hanuman Dhoka's Durbar Square.

(GPR): (a) around the Kasthamandap; (b) east of the Maju Dega Temple, up to the palace; and (c) south of the palace complex (Figures 21 and 22). The GPR results next to the Temple and Kasthamandap are dominated by linear anomalies that are all interpreted as modern utilities, either for freshwater, sewer or electric cables. Unlike in Bhaktapur (Coningham et al. 2016a), the anomalies show as strong reflections (black) and it is hence assumed that the pipes themselves are imaged. All extended anomalies next to these linear features are also interpreted to be of modern origin, probably forming the interconnection of structures for the utilities. Some of these coincide with metal man-holes or grills that were noted during the Total Station survey. In the southern part of the Maju Dega area, several of these linear anomalies appear interrupted for no apparent reason.

Next to the Kasthamandap, the only remaining anomalies that may be of archaeological origin are those to the west of the Temple in the narrow alleyway; and underneath the platform south of the structure. The latter show the edges of a bulge with c. 2.5 metre diameter that gradually becomes smaller with depth. Similarly, there are slightly extended areas of high reflectivity to the north of the Maju Dega Temple and these may be of archaeological origin. To the west of the palace gate, are several separate areas of high reflection that may represent a destruction layer below one metre depth. South of the palace complex, an intriguing set of anomalies is recorded. Most prominent are two linear anomalies running east-west visible over c. 60 metre length, each 0.8 metres wide and with a centre-line separation of two metres. The most likely interpretation is that they are walls or wall foundations. In addition, there are two narrow linear anomalies (c. 0.15 metres wide) running south of the former at a slightly different angle. Their interpretation is uncertain but they could be utilities, connecting to the two square modern anomalies to their east. In addition to the two long wall-like anomalies, there are further extended anomalies in this survey area that may together represent former building structures.

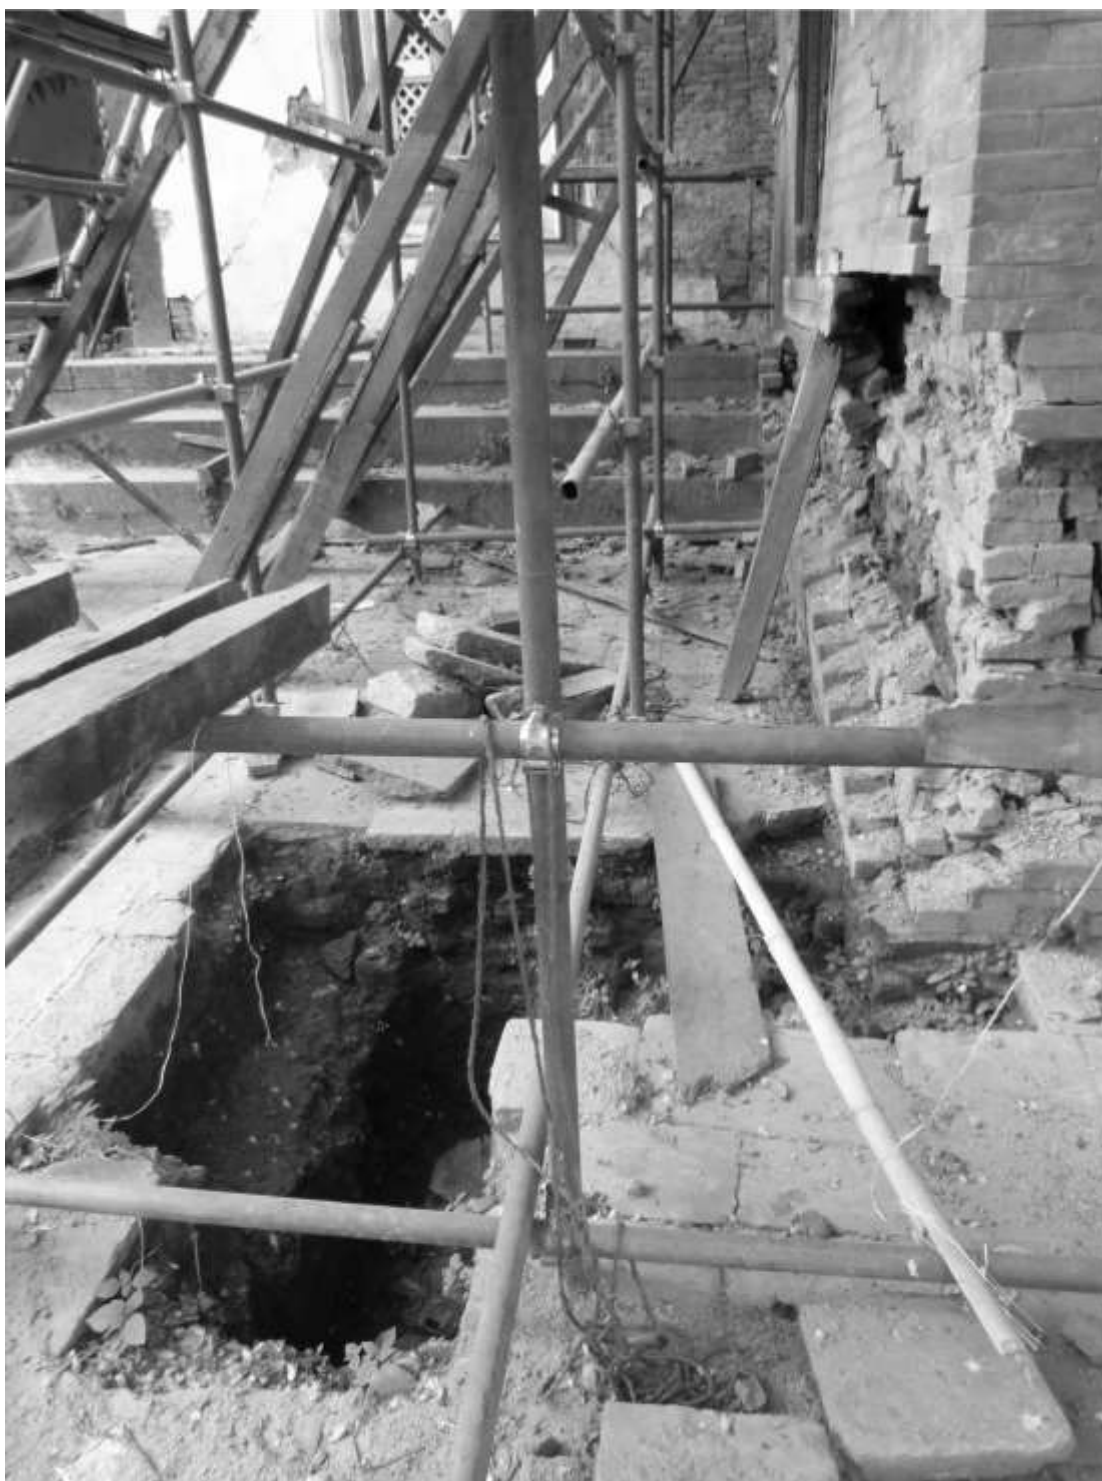
Figure 23: Unrecorded excavation trench cut alongside north facing wall of the Degutale Temple in Hanuman Dhoka's Durbar Square. Photographed in October 2015.

Universal Value. Indeed, we documented two examples of post-disaster interventions whilst within the Hanuman Dhoka. The first was represented by the cutting of evaluation trenches into the foundations of the Palace complex by engineers and architects without any archaeological recording (Figure 23). The second involved the cutting of foundations for new lampposts by the Municipality, again without any archaeological recording (Figure 24).

The damage caused by the earthquakes will require reconstruction and also the repair and laying of amenities in Hanuman Dhoka and whilst we do not recommend the suspension of the laying services and reconstruction we do advocate the mobilisation of rescue archaeology teams to undertake rescue excavations in advance of interventions (Coningham et al. 2016c). The Archaeological Risk Map for Hanuman Dhoka will provide information for site managers and stakeholders as to the risks posed to subsurface heritage and help guide future development (Figure 25). Indeed, from our observations and investigations, we feel there needs to be a heightened awareness that the cultural heritage of Hanuman Dhoka is not restricted to its standing remains and architectural treasures but that it should extend also to the foundations of these monuments and to preceding phases of cultural development, which are found below the current ground level. The Archaeological Risk Maps and our interventions should facilitate the development of this awareness and protect subsurface heritage whilst not being of detriment to reconstruction.

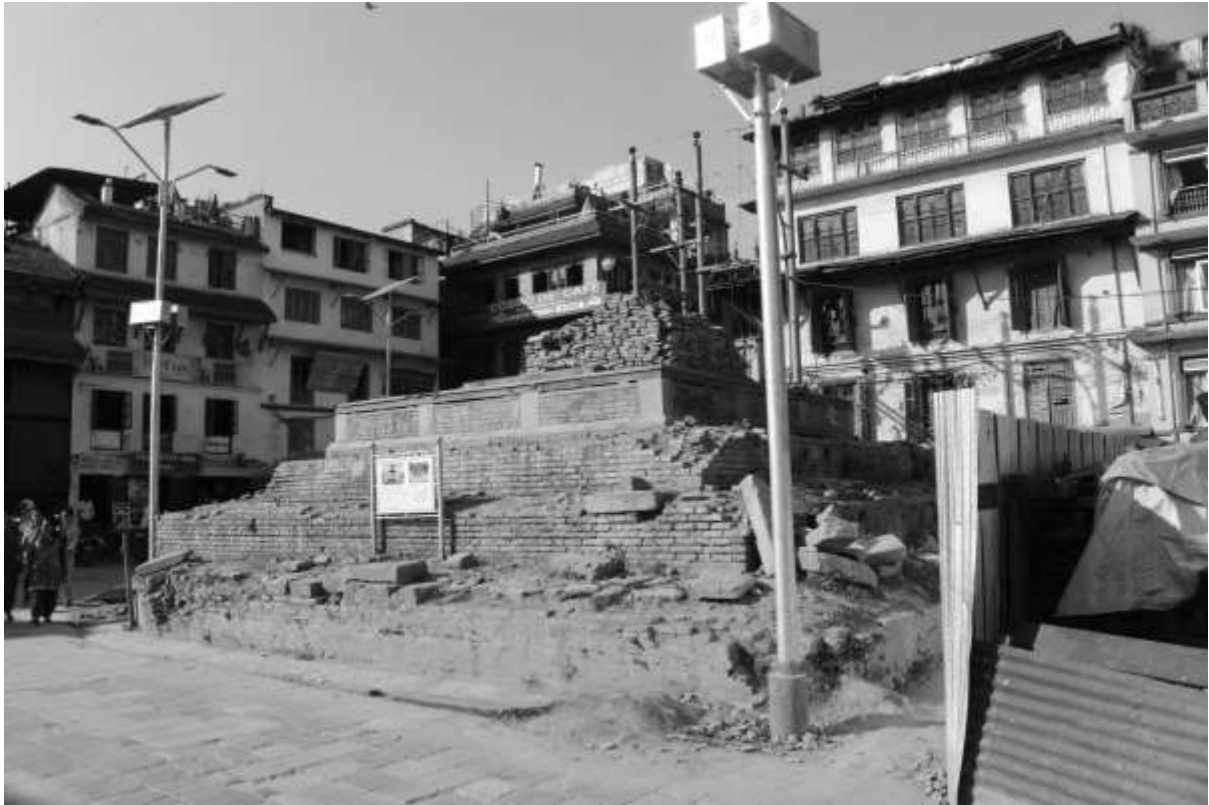
Figure 24: New lampposts installed on the corners of the Narayan Temple, Hanuman Dhoka Durbar Square.

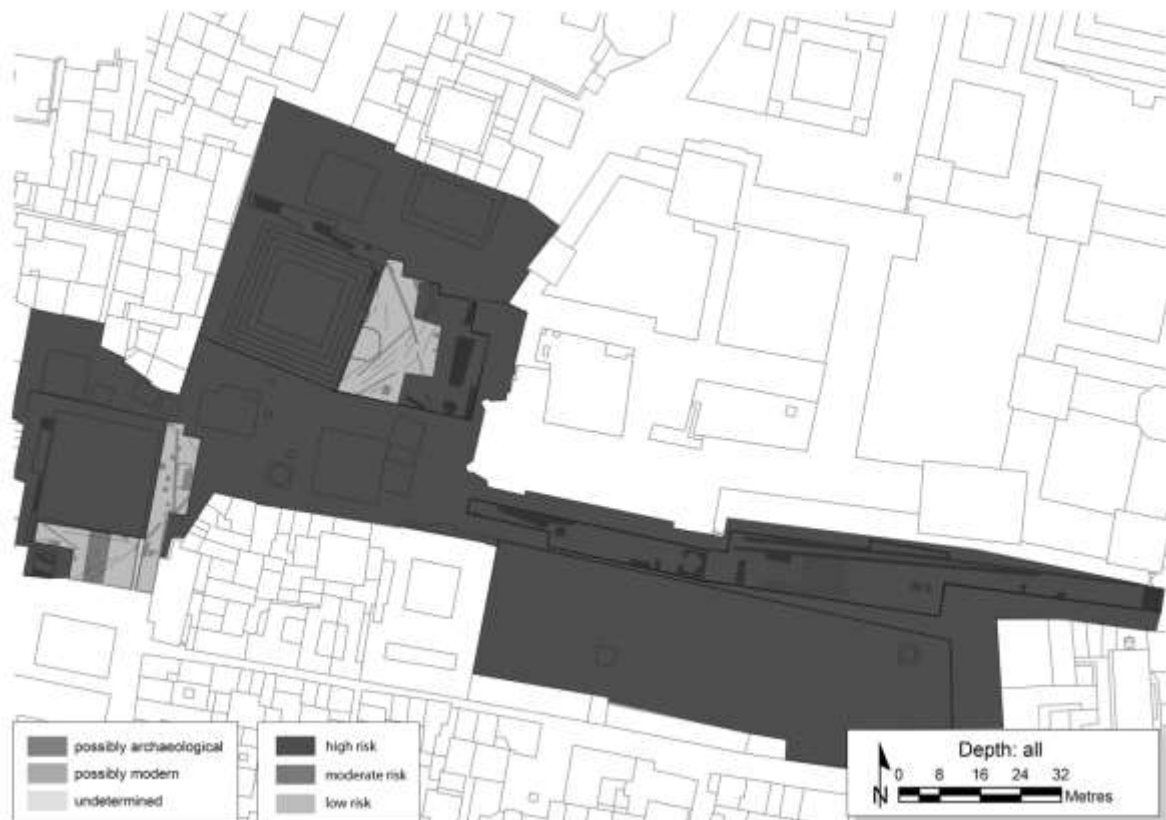
Figure 25: Provisional Risk map for Hanuman Dhoka's Durbar Square.

The archaeological investigations at the Kasthamandap and within Hanuman Dhoka's Durbar Square have illustrated the extent of subsurface heritage within the World Heritage site. The GPR survey has highlighted areas of potential archaeological features below the current square and excavations have revealed the character of some of these signatures. What is clear is that the Durbar Square was not always an open space but has developed over time, only in the last few centuries reaching its current configuration of standing monuments. One of the key features identified through GPR survey and excavation were pipelines and other amenities running through the Durbar Square, which we have demonstrated have cut through archaeological stratigraphy and earlier phases of human activity. Such interventions are therefore a concern as the laying of any infrastructure has the potential to damage and destroy subsurface heritage of this site of Outstanding

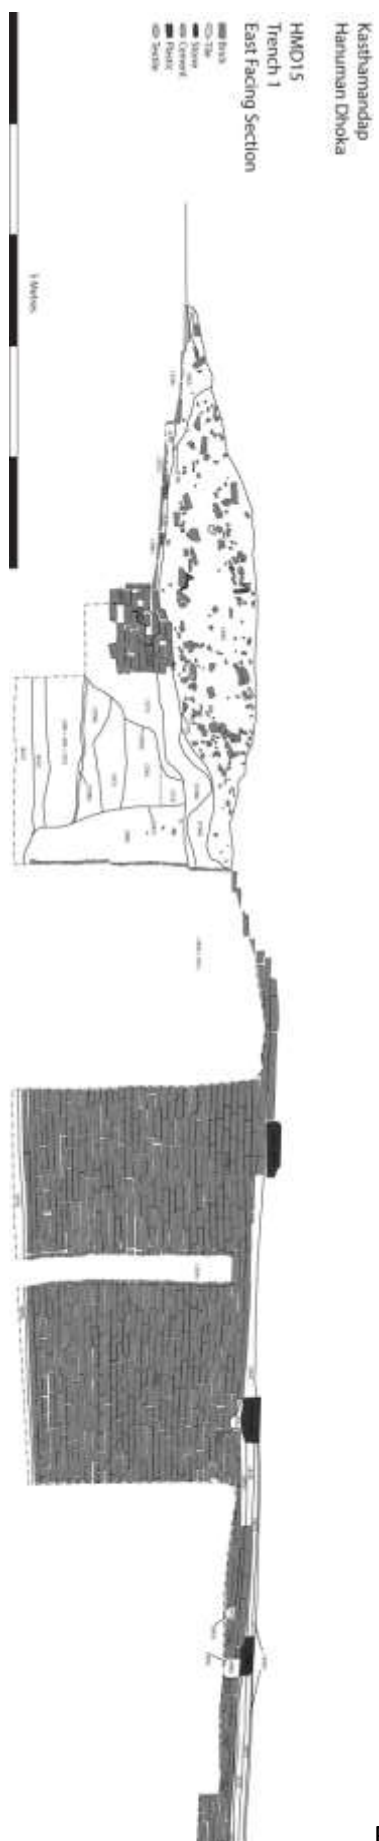
HMD15
Trench 1
East Facing Section

Figure 26: East facing section of Trench at Kasthamandap.

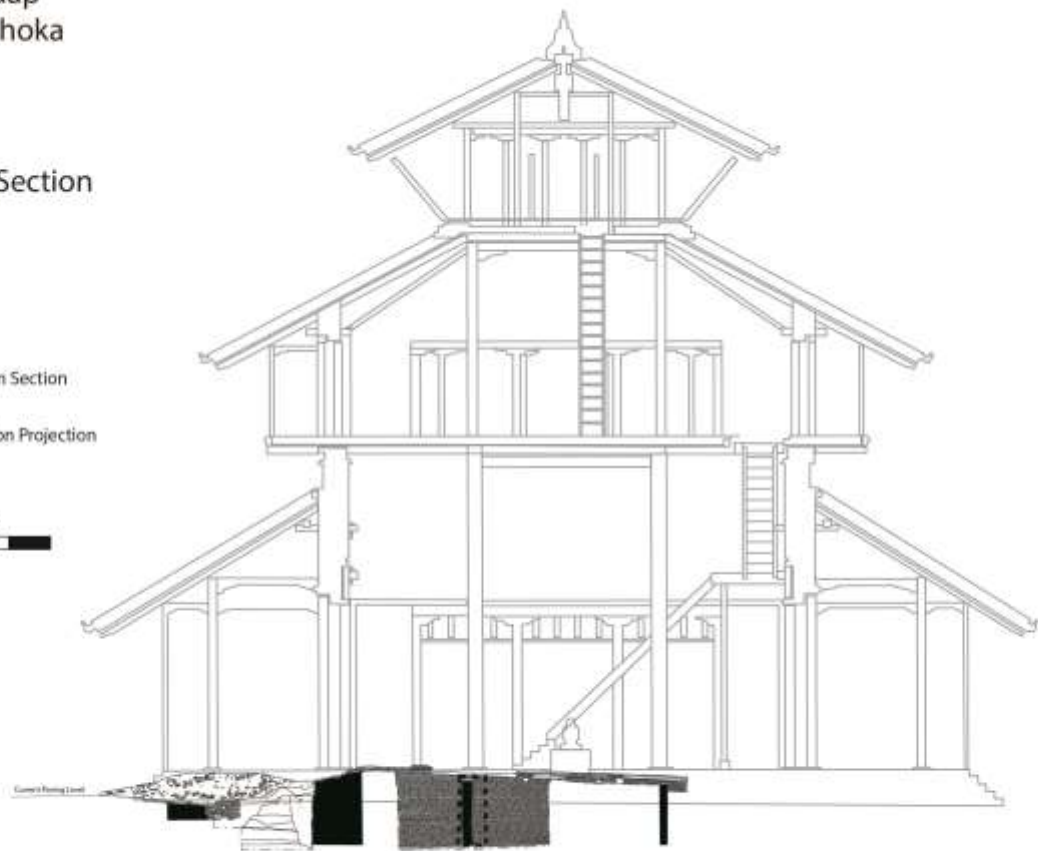
Figure 27: East facing section of Trench, illustrating depth of foundations, with superimposed elevation of the Kasthamandap before collapse (Elevation of Kasthamandap, after Korn 2007).
